**Title:** **Hernando de Soto Bridge Emergency Repairs**

# Hernando de Soto Bridge Emergency Repairs

ESWP Project of the Year  
Submitted by Michael Baker International

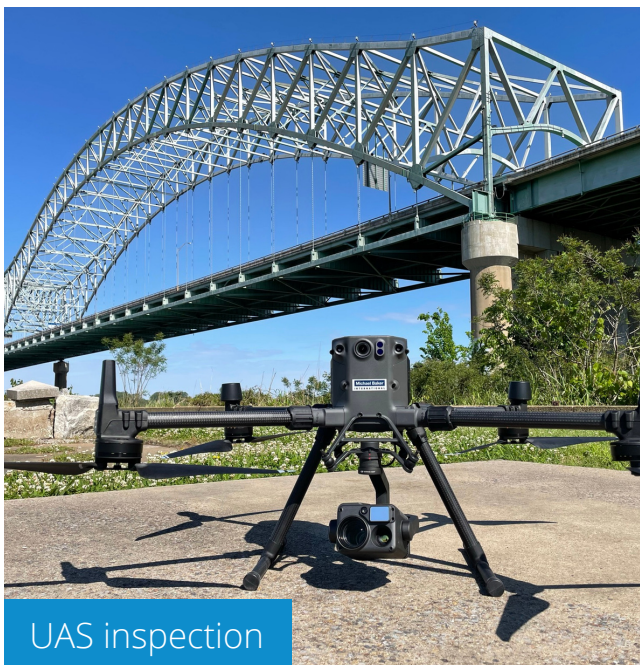
The Michael Baker team first leveraged their considerable experience with unmanned aircraft systems (UAS) – or drones – to fly the fracture location to inform ARDOT and TDOT of the apparent extent of the damage. The initial UAS video confirmed that the fracture included the complete loss of one of the two web plates, one of the two flanges and partial fracture of the second flange. More than 50% of the member cross-section was lost in the fracture. Within hours, engineers from ARDOT, TDOT and Michael Baker were working toward the ultimate goal of safely repairing the fractured tie girder. At this time, Michael Baker was contracted for design of an emergency repair by TDOT.

UAS inspection

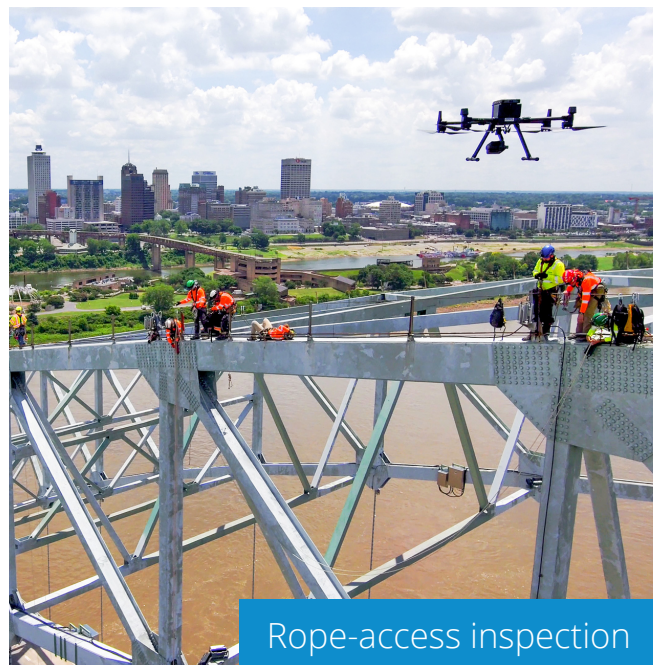
Rope-access inspection

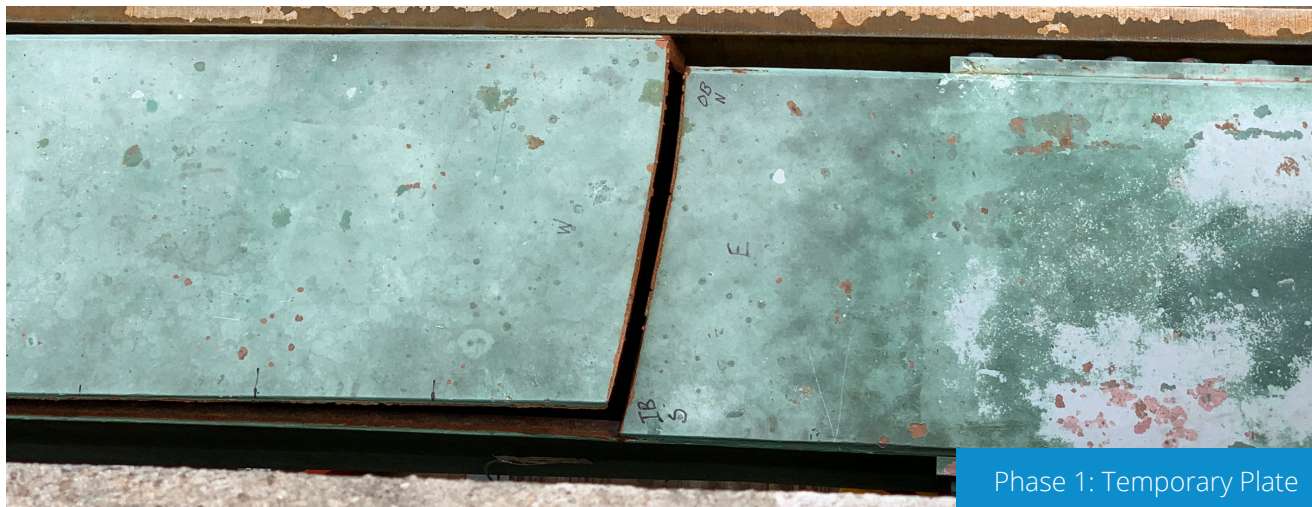
Phase 1: Temporary Plate

The Michael Baker team took a “do no harm” approach to the initial repairs as there was concern that the bridge was severely compromised. The initial evaluations found the remaining section was dangerously close to yielding. The Michael Baker team found no evidence from the structure that the load had found an alternate path beyond the opposing web and remaining flange. Stabilizing the member was not a long-term fix, but it was the first step toward the repair, ensuring the safety of subsequent phases of work. The Michael Baker team established safe working load levels for construction crews and equipment staged on the bridge. Within the first week of the closure, a stabilization splice was designed to temporarily restore the capacity of the fractured section of the tie and the fabrication of roughly 30,000 lbs. of structural steel plates began by Stupp Bridge. To install the splice, Kiewit assembled a suspended platform from which iron workers secured the plating with nearly 450 temporary bolts. The splice provided additional redundancy to the partly severed member without applying any corrective twist or loading to the damaged tie. The suspended platform allowed the contractor greater access to establish a more permanent repair in Phase 2.

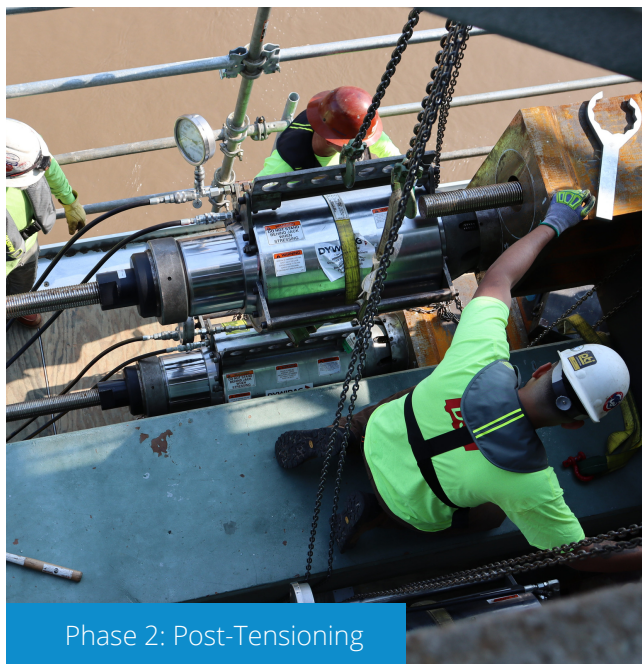
Phase 2: Post-Tensioning

The final solution from Michael Baker consisted of using external post-tensioning to reduce tension in the existing tie, lessening its level of stress and possibility for further damage. Eight 3" diameter high-strength steel post-tensioning tendons were connected to steel weldments at either end of the fractured tie.

High-pressure rams were utilized to deliver the required force to partially de-tension the tie. Extensive real-time monitoring of the post-tensioning operations was implemented to ensure success. While the tie was partly unloaded, the temporary Phase 1 stabilization plates were removed and new strengthening plates were installed that have nearly the capacity of a completely intact tie by themselves.

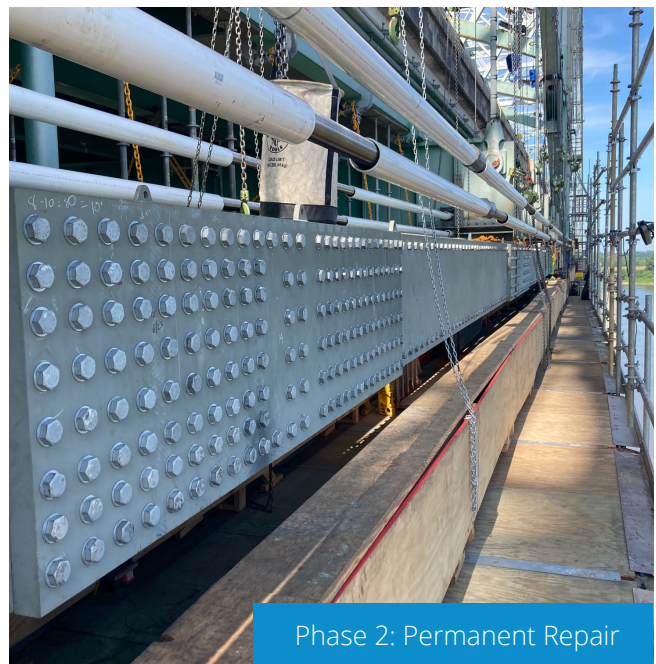
Phase 2: Permanent Repair

These new plates, acting in tandem with the existing steel, provided a redundant load path in the unlikely event of future fracture. The Michael Baker team worked closely with Kiewit and fabricators W&W/AFCO and G&G Steel to design the repair around readily available HPS70W material.
