# Green Infrastructure on Brownfields

Tysen O. Miller, PE, LEED AP, CPESC – KU Resources, Inc.

Jim Pillsbury, MS, PE – Westmoreland Conservation District

October 3, 2018

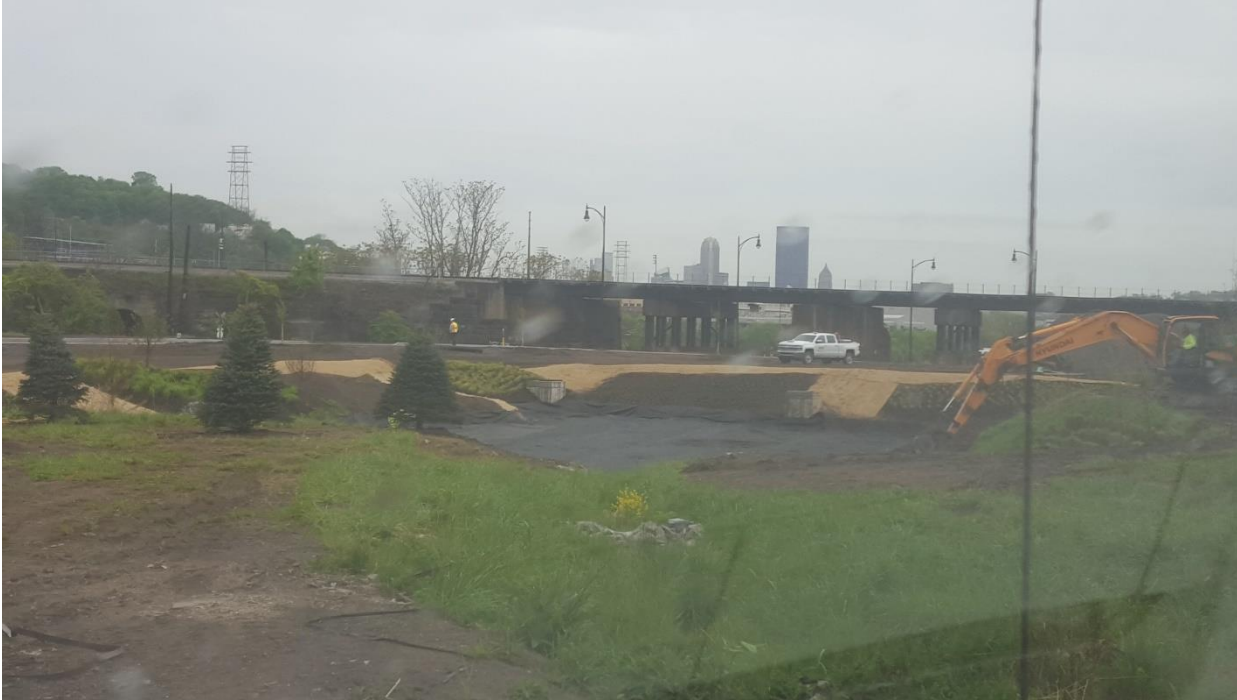
- May require HDPE or Geosynthetic Clay Liner

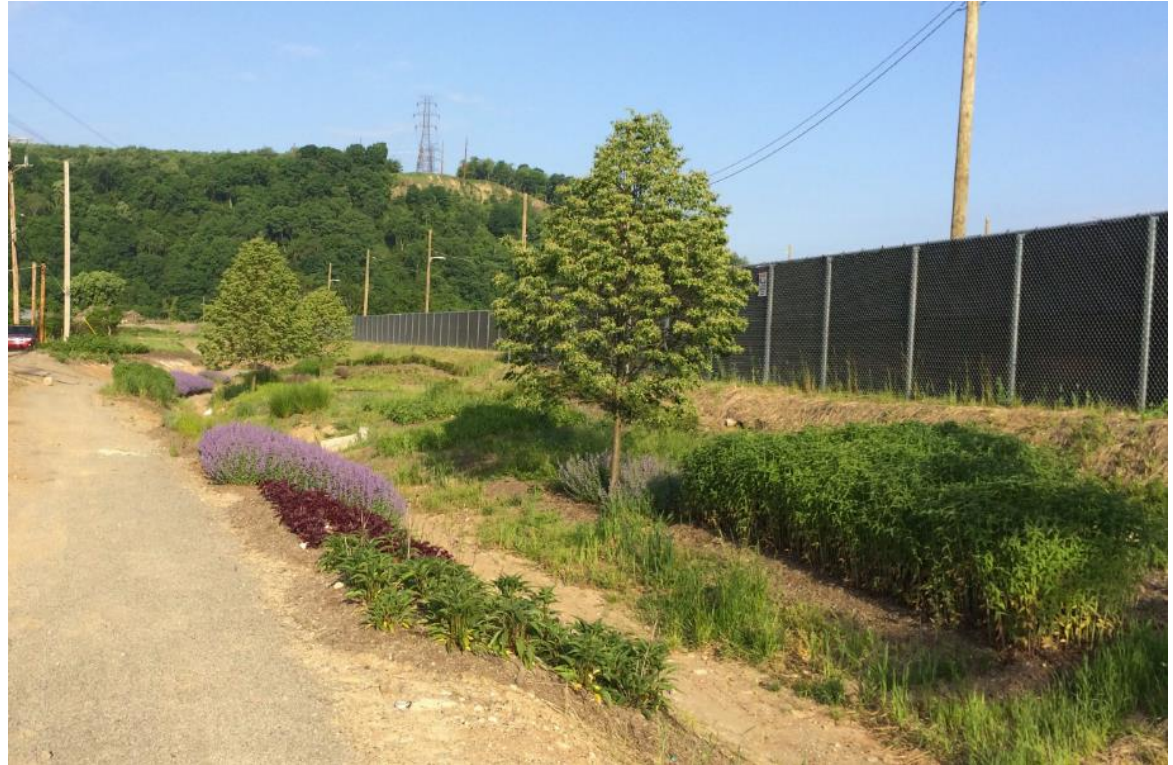
Infiltration islands and bioswale reduce urban runoff to a combined sewer

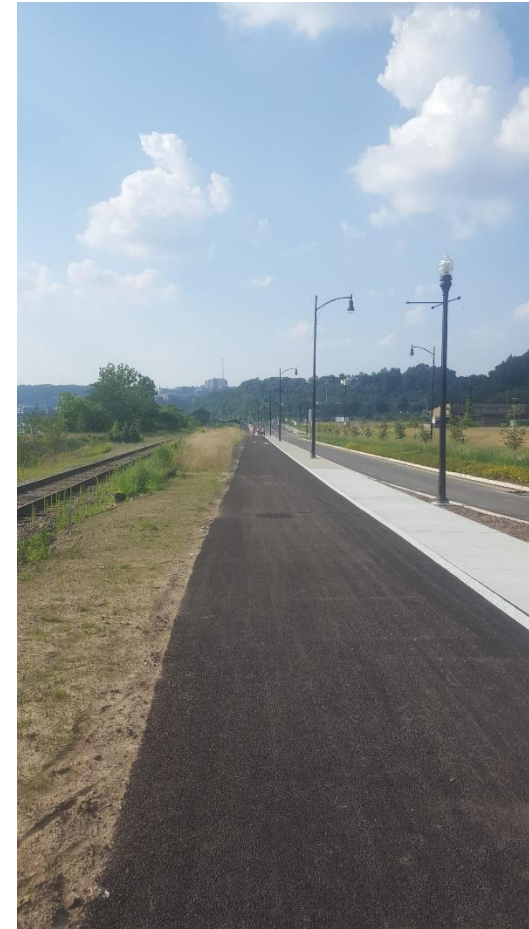
Permeable paving demonstration showing varied porosity

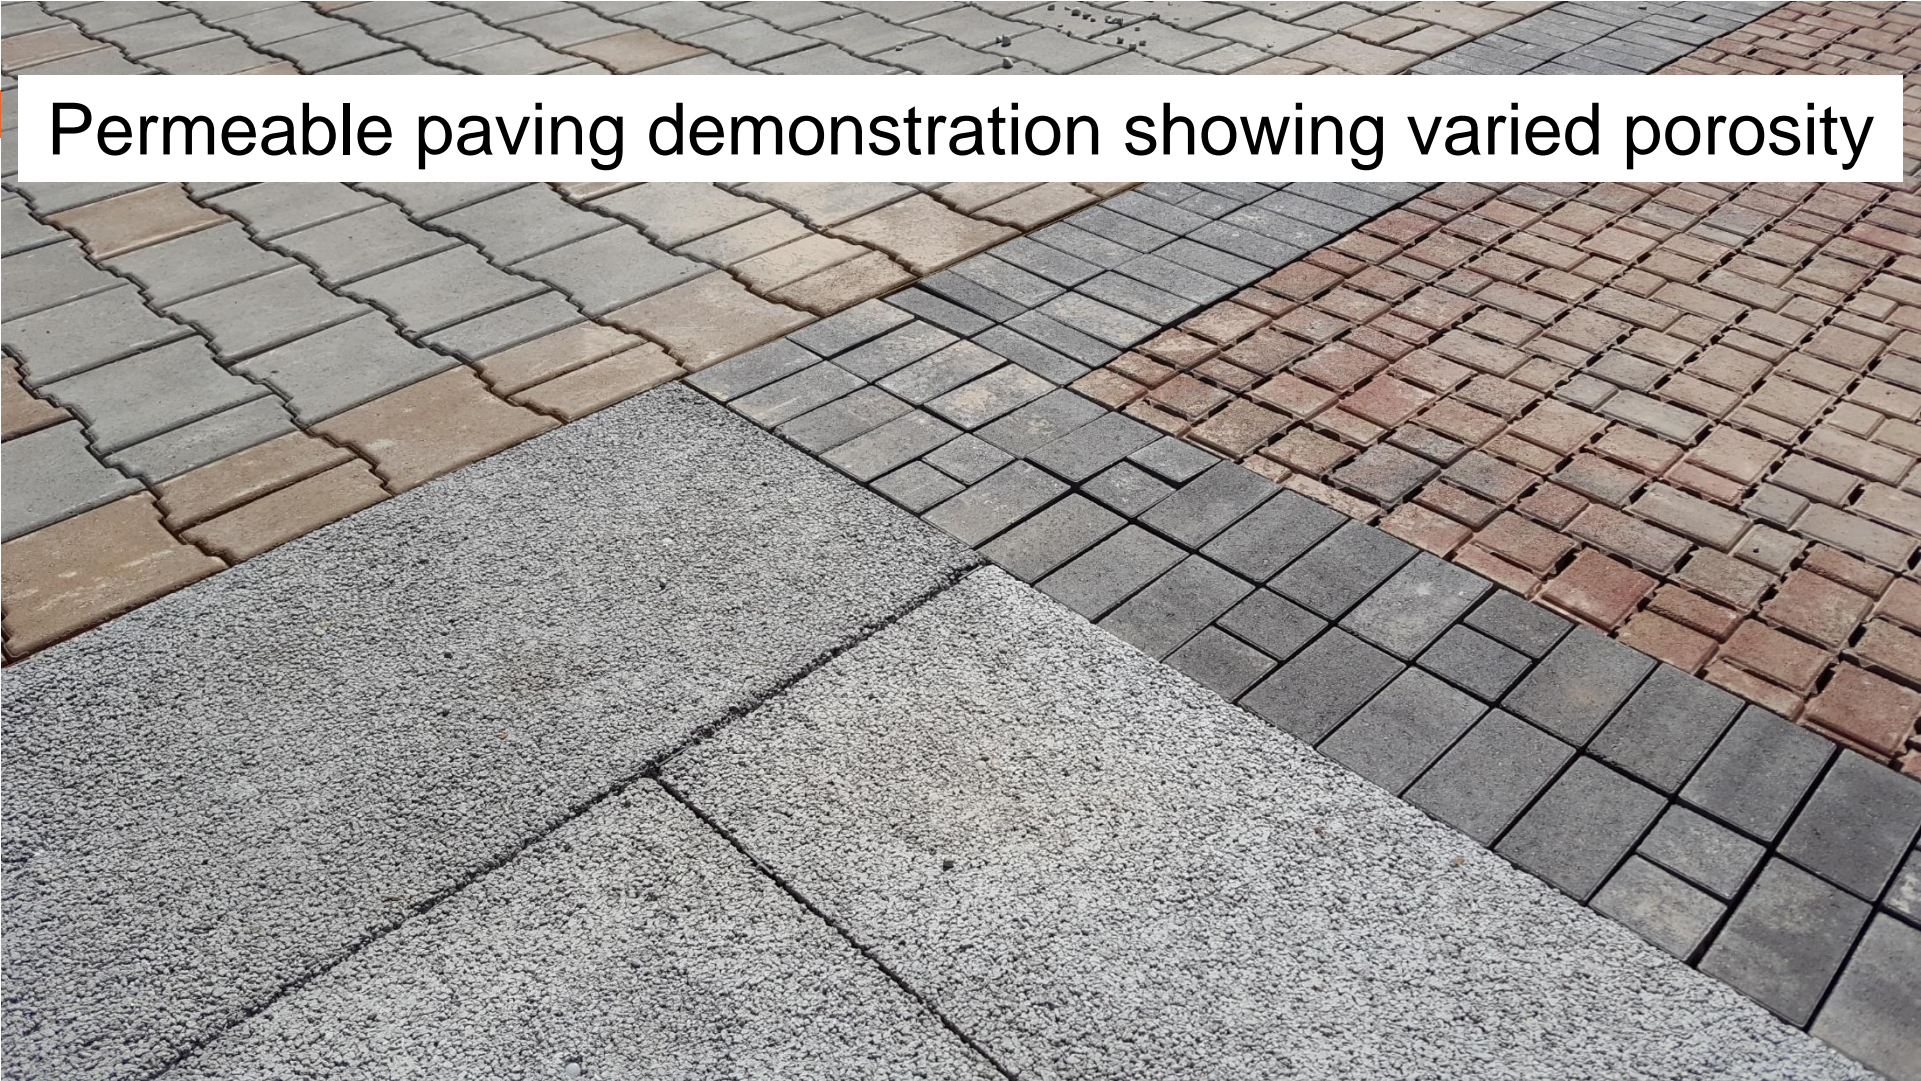
Rain disappears through gaps and pores

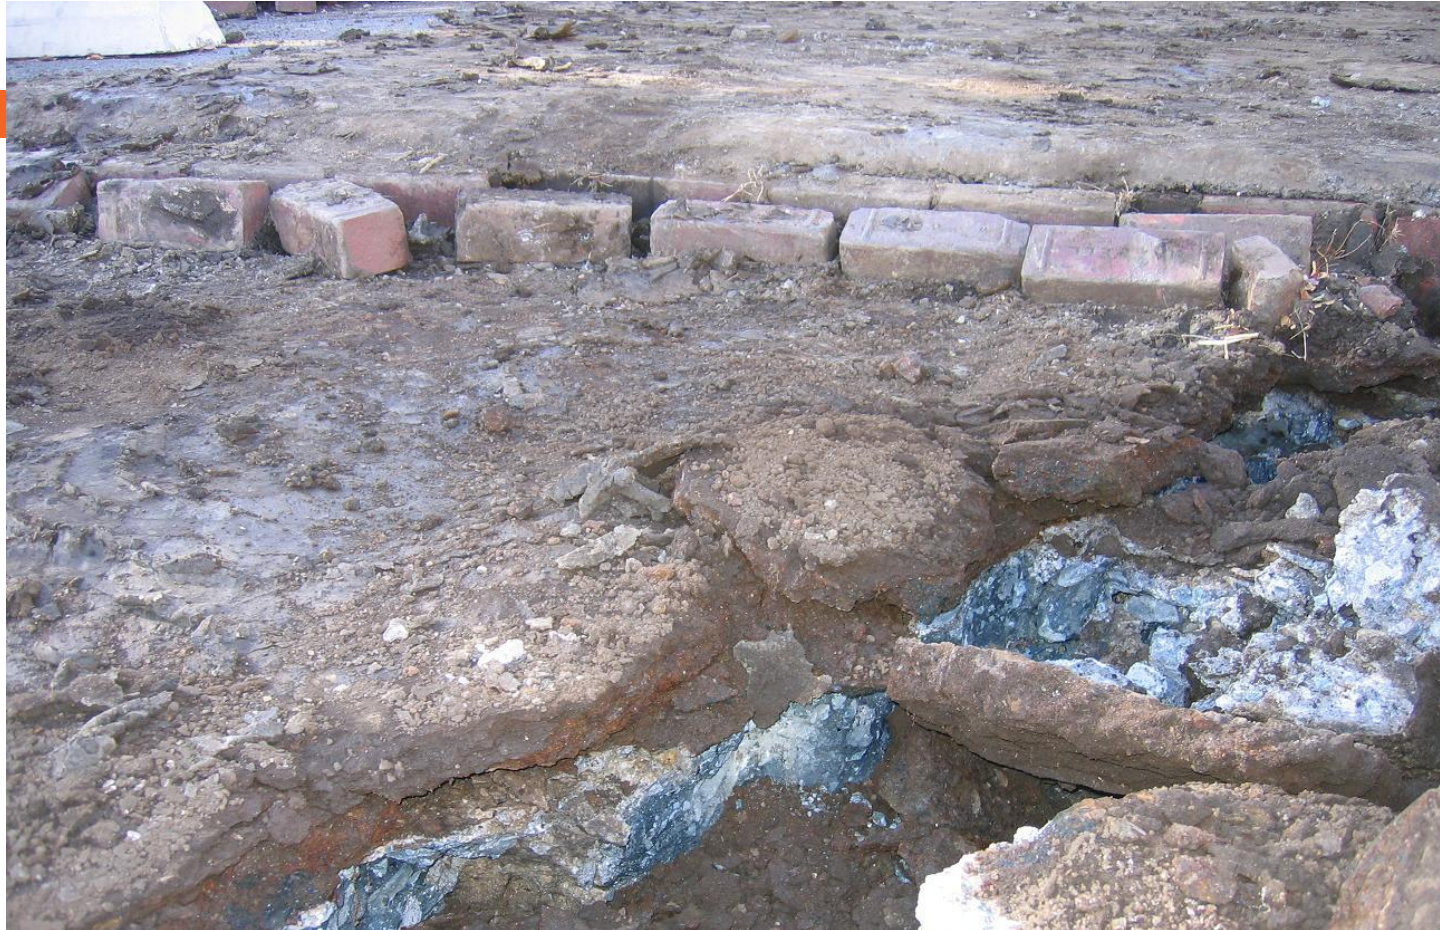
Demolition layers: 3" asphalt, 3" brick, 4" fly ash, 8" concrete

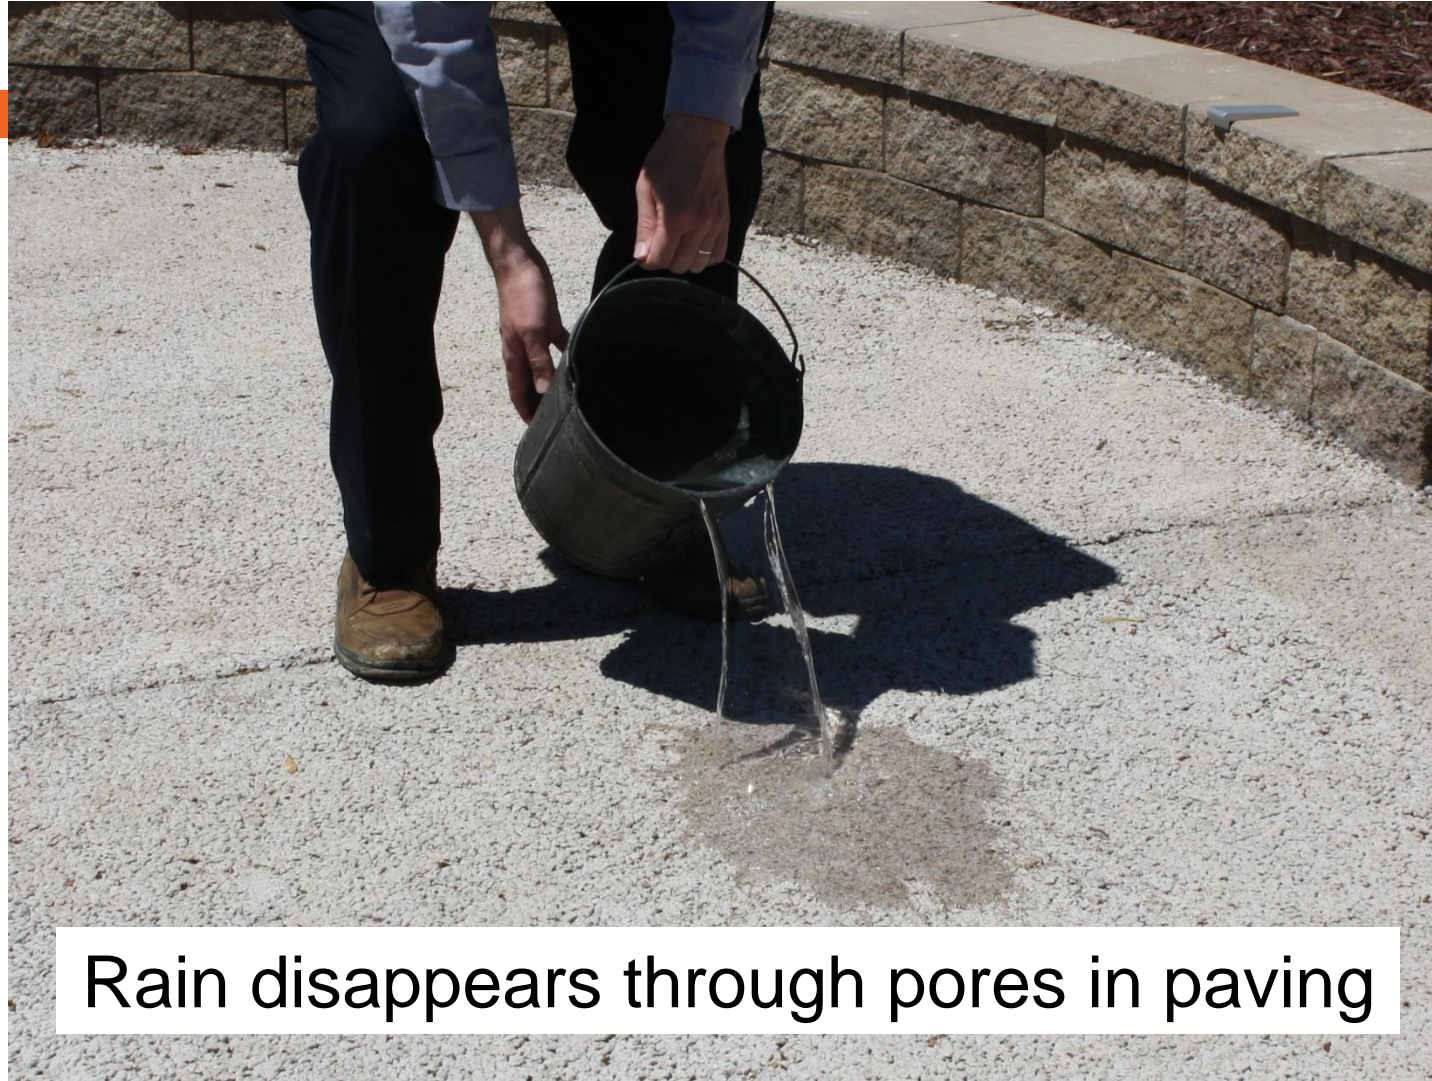
Rain disappears through pores in paving

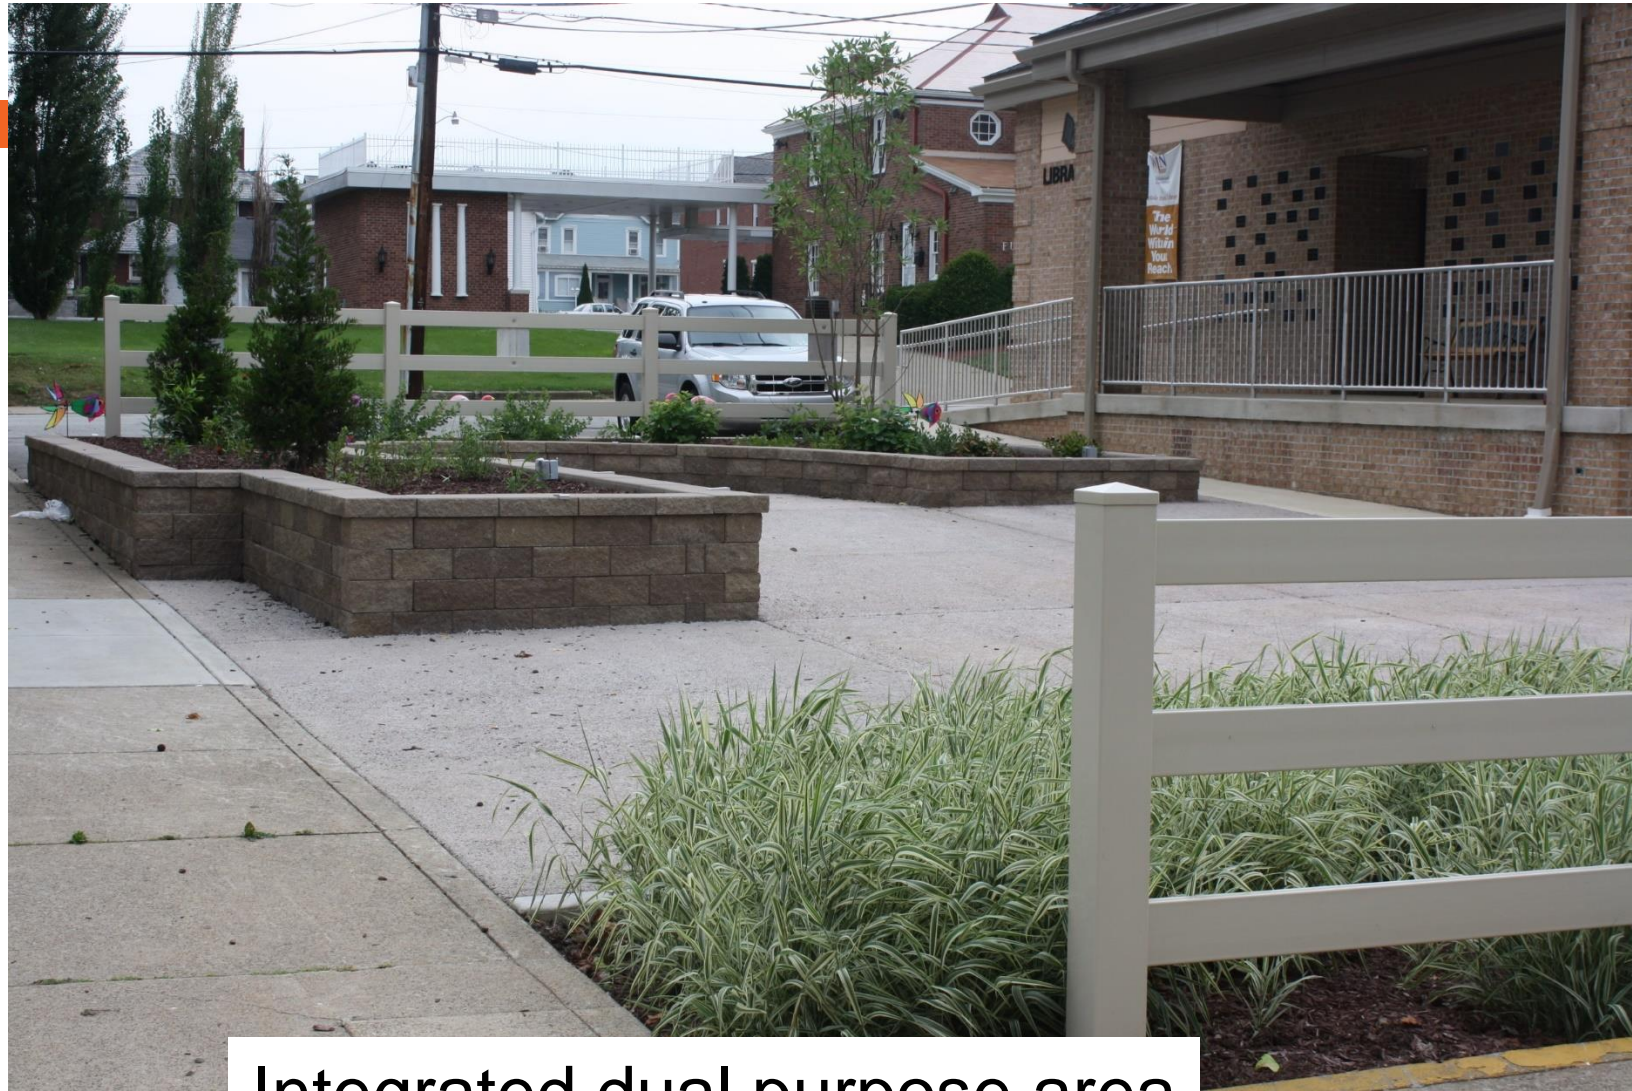
Integrated dual purpose area

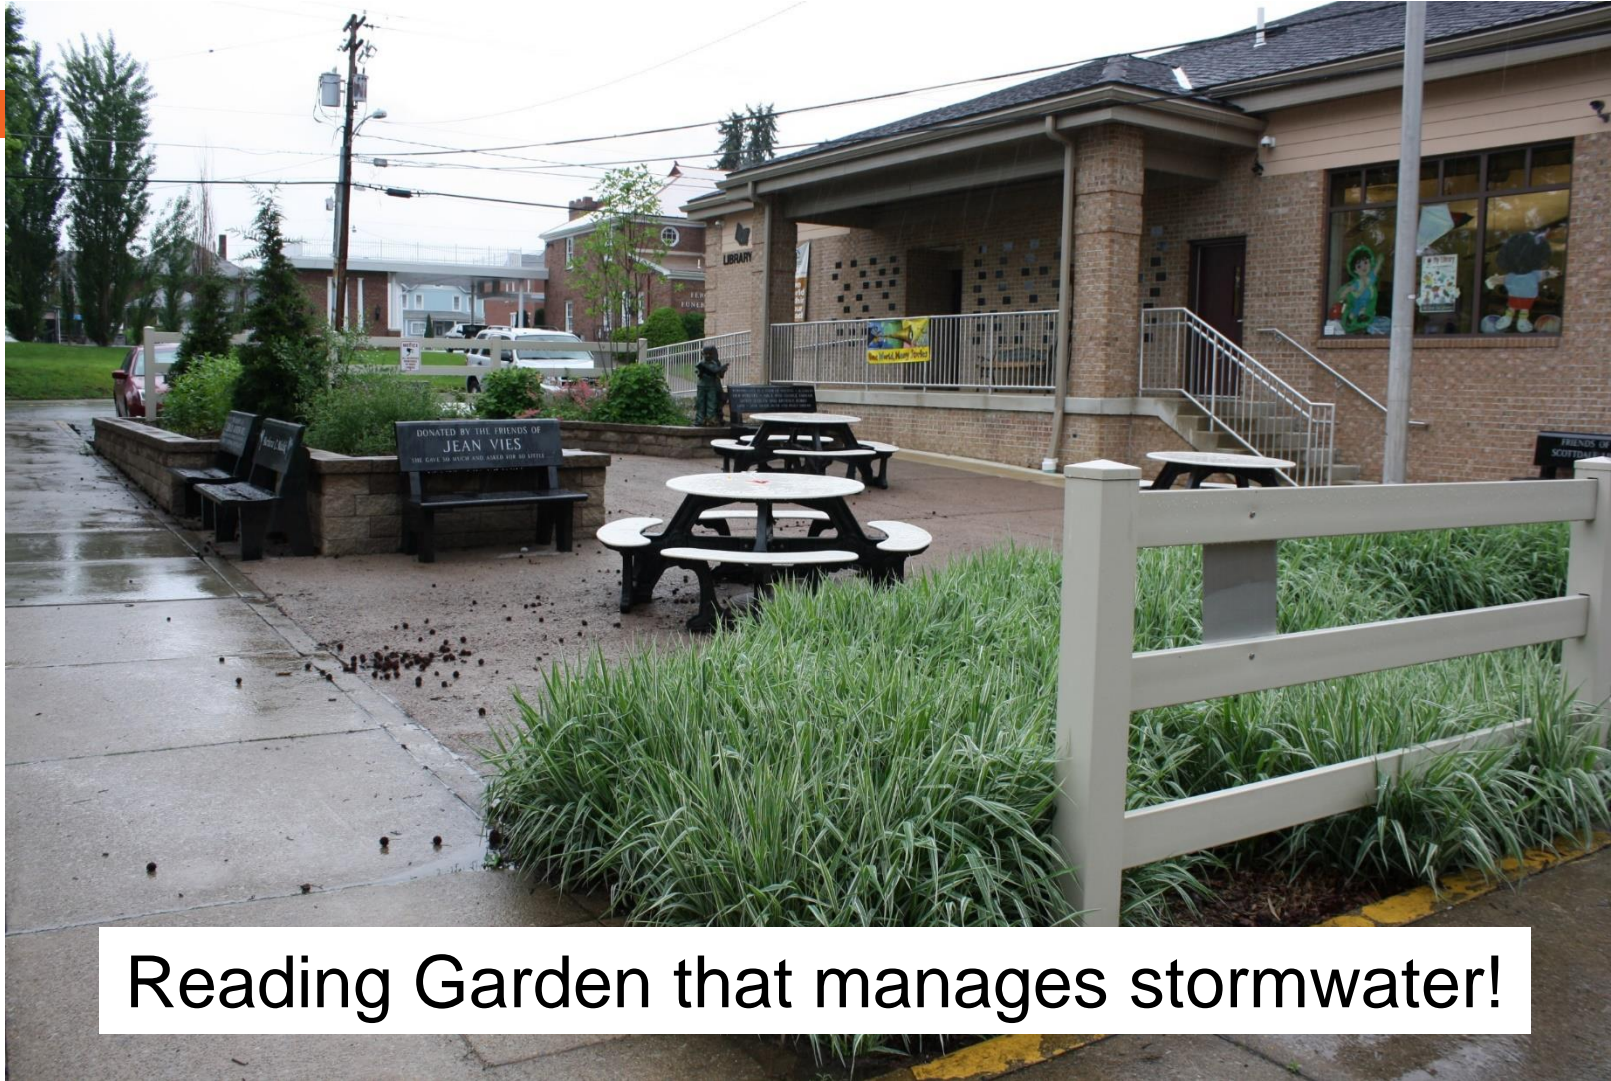
Reading Garden that manages stormwater!
