Pittsburgh

SPRING 2019

ENGINEER

ENGINEERING EMERGENCY RESPONSE

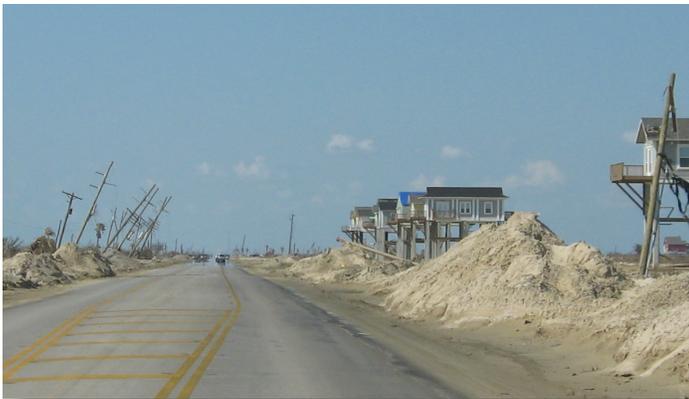
Damage to electric power infrastructure in Texas after Hurricane Ike

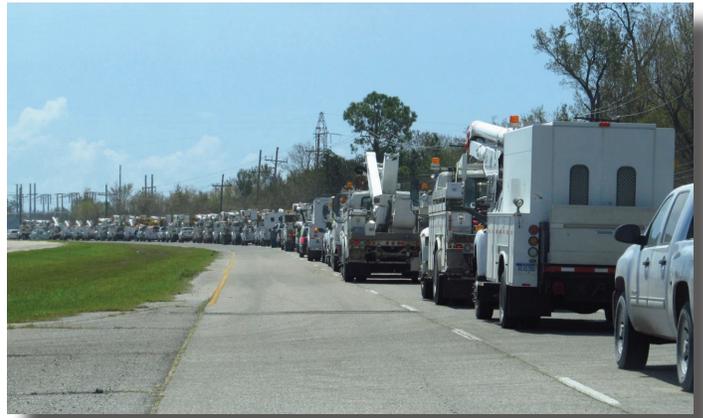
Electric utility trucks lining up after Hurricane Isaac to restore service along Louisiana HWY 23, south of New Orleans.

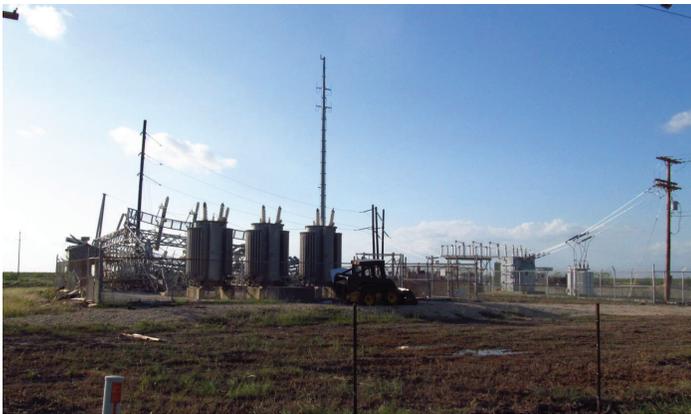
A utility substation flattened by Hurricane Harvey. A temporary transformer used to restore service can be seen on the right.

Use of various restoration technologies is also an important component of improving resilience by reducing the restoration time during an extreme event. Initially, increased use of drones and remote sensing devices increase situational awareness, by allowing a faster identification of areas in need of repair. Once these locations are identified, electric utilities implement various technologies in order to accelerate the restoration time. Substations are a component of power grids that are particularly important because of the large number of customers that are usually affected when a substation is damaged.

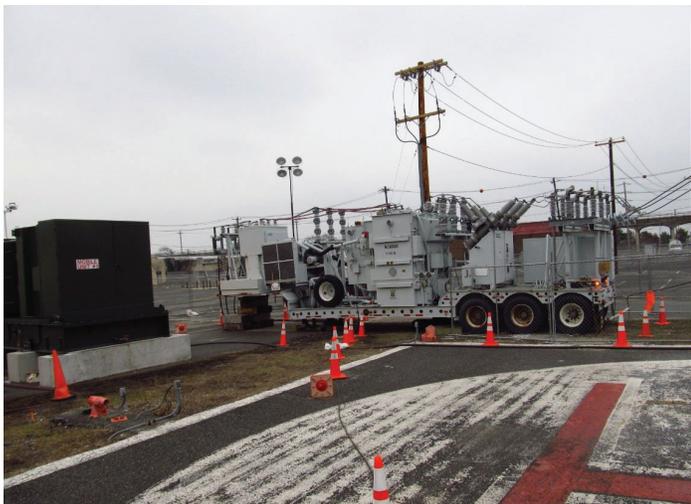
A mobile substation used to restore service to a destroyed substation (in the background) after Superstorm Sandy

Use of mobile substations with transformers and switchgear mounted on trucks is a technology that has increasingly been used in the aftermath of natural disasters around the world in order to restore service to substations. Transmission and sub-transmission lines represent another set of electric power grid infrastructure and components that are particularly

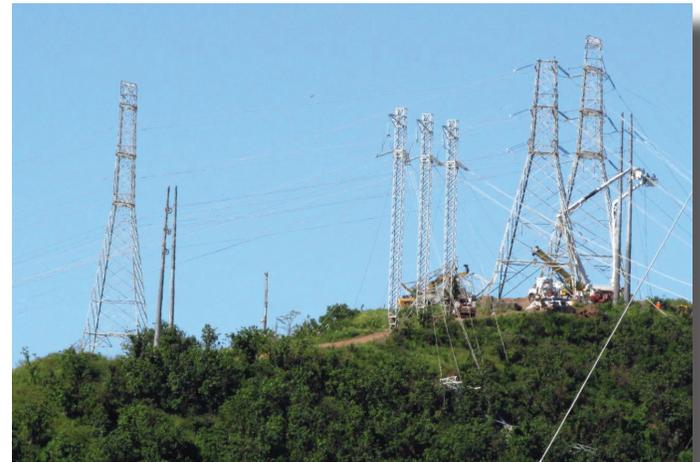
A temporary transmission line under construction to replace a damaged line. Remains of a downed transmission tower are observed in the foreground.

critical. In many cases, these lines are restored with provisional towers until long term repairs can be completed. Still, in some locations, even temporary lines take too long to be constructed. In these cases, electric utilities sometimes use diesel generators to power a subdivision or large building until lines are repaired.

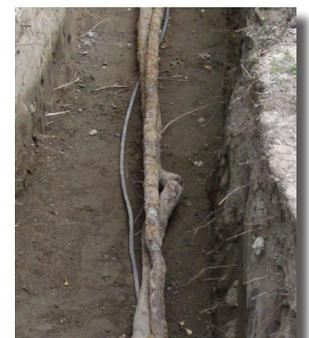
One of the many buried cables damaged during the February 2011 Earthquake in Christchurch, NZ.

resilience indirectly due to the high financial stress that electric utilities may have when paying for the investment of underground facilities. Moreover, underground cables also have a higher repair cost and longer replacement time when a fault occurs under normal conditions happen. Regardless, each case is different and the cost/benefits must be weighed to determine the best approach to resiliency.

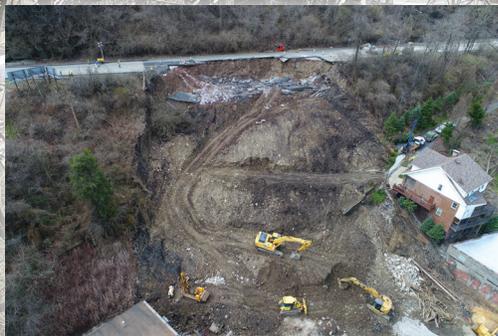
Aerial view of Route 30 as hillside stabilization work begins

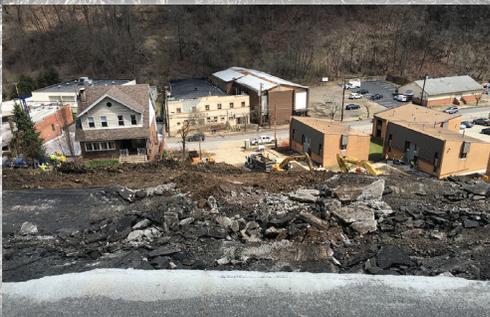
Looking down from Route 30

On April 7, 2018 a significant landslide resulted in the closure of Pennsylvania State Route 30 in Allegheny County. The route is a principal artery to Pittsburgh and supports more than 22,000 vehicles per day. The slide demolished one apartment building, severely damaged another, and impacted a single-family home.

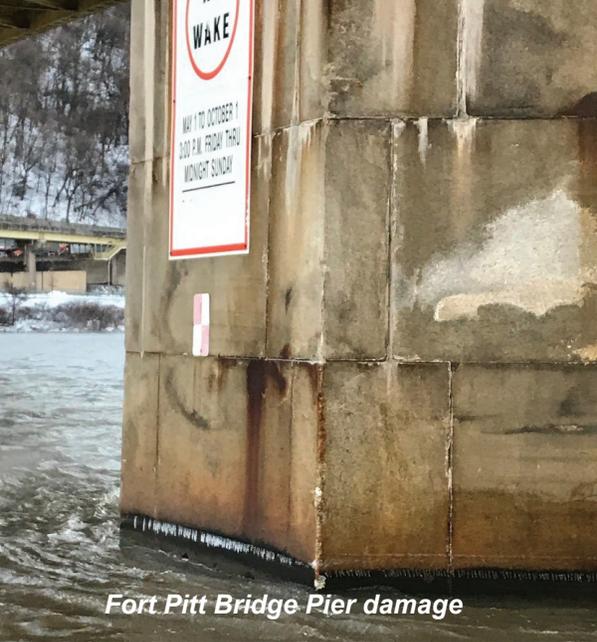
Fort Pitt Bridge Pier damage

- Liberty Bridge: did not have any notable damage to any of its piers.
- Smithfield Street Bridge: impacted at the two piers at the south end of the structure (Pier 04/Pier 05). There are currently two barges still stuck at the upstream side of these piers. One is floating and the other is partially submerged. There was minor scape damage to the pier above the water level and no other issues noted. A follow-up underwater inspection was scheduled to review the foundation for erosion of material under the footer that the barge could be causing and found no issues. (
- The Fort Pitt Bridge was impacted at the upstream nose of the north river pier with very minor damage and no visible settlement problems at the bearing area.

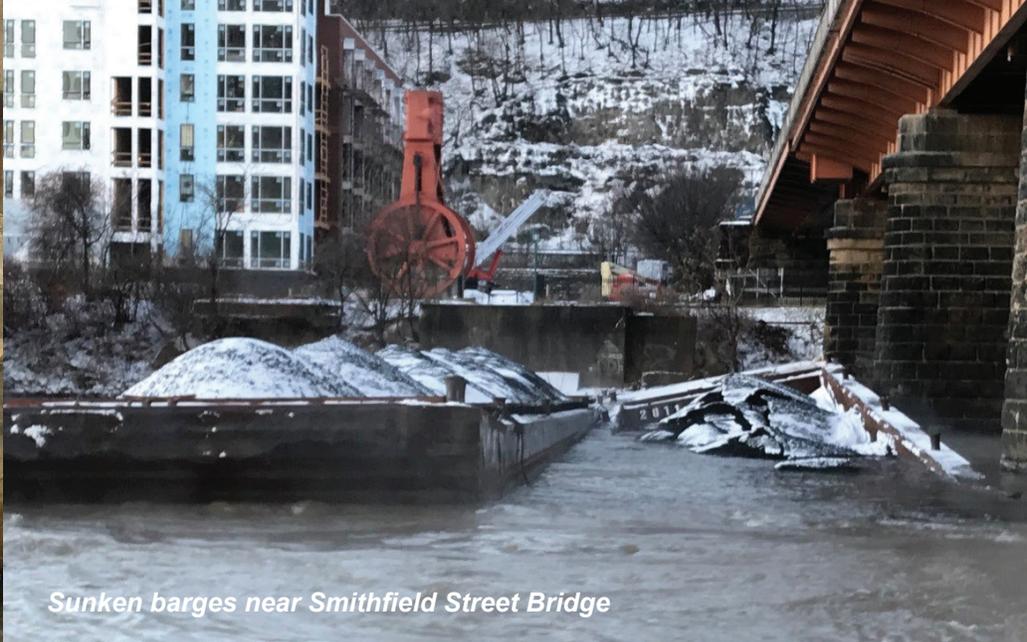
Sunken barges near Smithfield Street Bridge

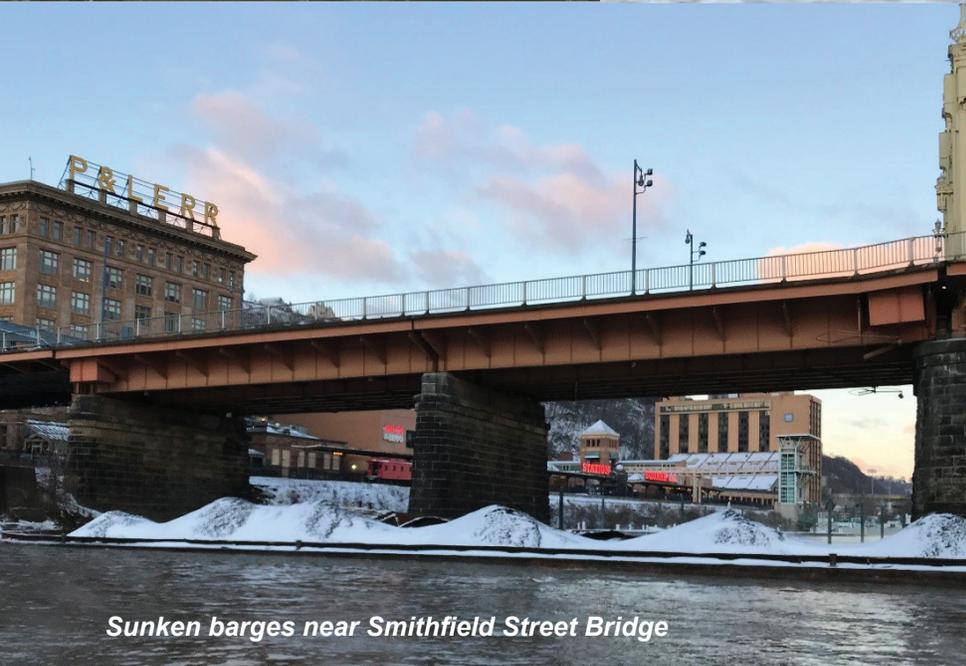
Sunken barges near Smithfield Street Bridge

A follow-up underwater inspection on the Smithfields Street Bridge was performed on January 29, 2019 by Infrastructures Engineers. This report documented approximately 18-ft in height of numerous fractured, missing, and/or dislodged stones to the nose of Pier #7. The damage above the water line extended approximately 10-ft with approximately 8-ft of damage below the water line. PennDOT also followed up with an underwater inspection of Smithfield Street Bridge, since barges were sunk very near one of its piers.

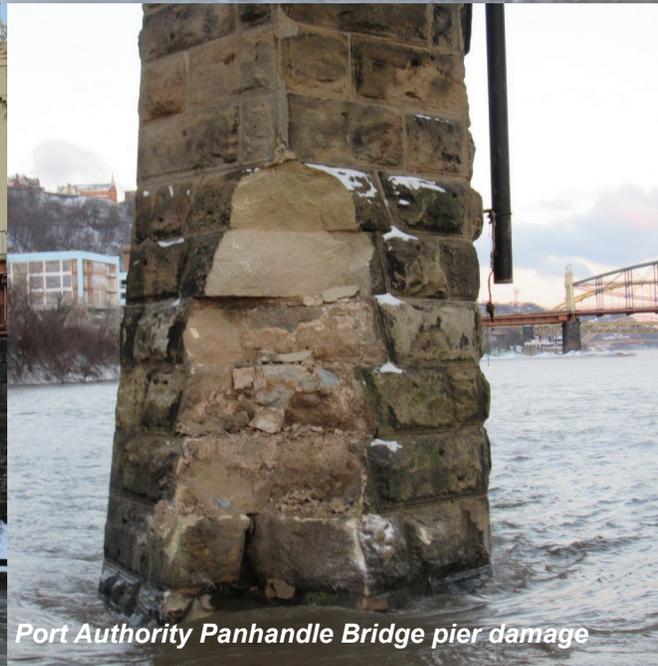
Port Authority Panhandle Bridge pier damage

The Port Authority coordinated their inspections with their staff to look at both the subway rails and piers of the Panhandle Bridge. In addition, PennDOT inspectors in the River Rescue Boats also looked these piers on their way back from Liberty Bridge. This bridge sustained the most damage out all the bridges, with a 10' chunk of the pier nose being knocked off. Their inspections were completed and the bridge was re-opened by 10:00 a.m.

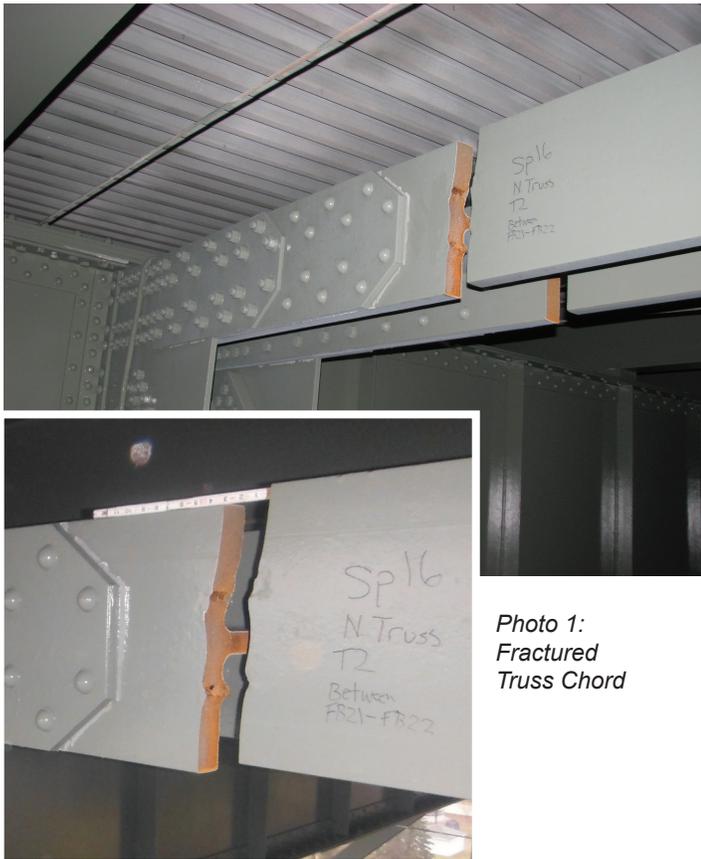
*Photo 1:
Fractured
Truss Chord*

The location of the fracture was on the Pennsylvania side, Span 16, in the four-span continuous deck truss. The large member, also known as a “jumbo” member, was a W14 x 314 rolled section of the top chord, north truss. These jumbo members were used in areas of high load and stress and were rolled from high strength manganese steel. These members can suffer ductility loss and embrittlement from welding which is generally prohibited where this type of steel is selected. There was no welding specified on these members and none should have been done.

After this fracture occurred, the bridge did not really show any change in stability and function. The surface corrosion evident on the fractured surface suggested that the fracture may have occurred days or even weeks prior to being discovered. The brittle nature of the fracture with no ductile behavior in the base metal suggested that the fracture was immediate and shook the structure as evident by the cracked paint at the adjacent gusset plate connection. (See Photo 1)

The fracture would later be identified as a brittle fracture through the entire section initiating from two mis-drilled holes filled with weld material. This welding induced a stress riser condition in the manganese steel of the member. The belief is that this weld material was used in an attempt to correct these mis-drilled holes in the shop during the original fabrication.

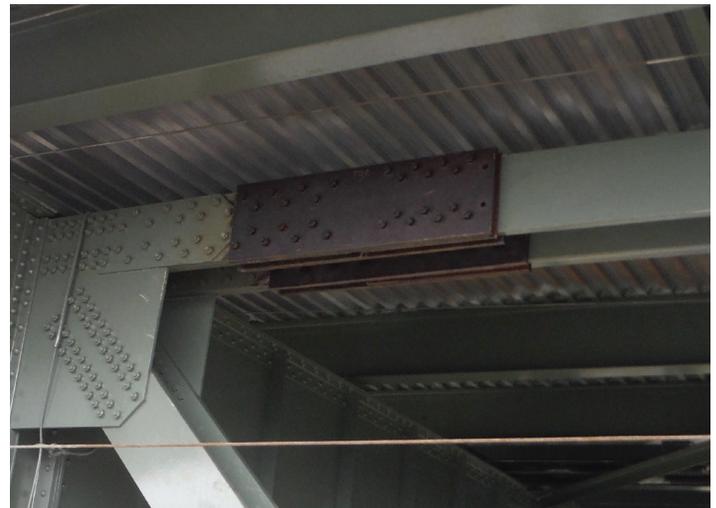
Photo 2: Temporary Splice

With the traffic removed from the bridge, the first step of the repair effort was to stabilize the member. Even though the bridge had been carrying live load during a period after the fracture and the truss had redistributed the loads, the intent was to ensure the stability of the structure. The decision was made to immediately place a temporary splice to tie the two fractured ends back together. The intent of the splice was to make a flush connection; not to bend the member or restore any geometry. (See Photo 2)

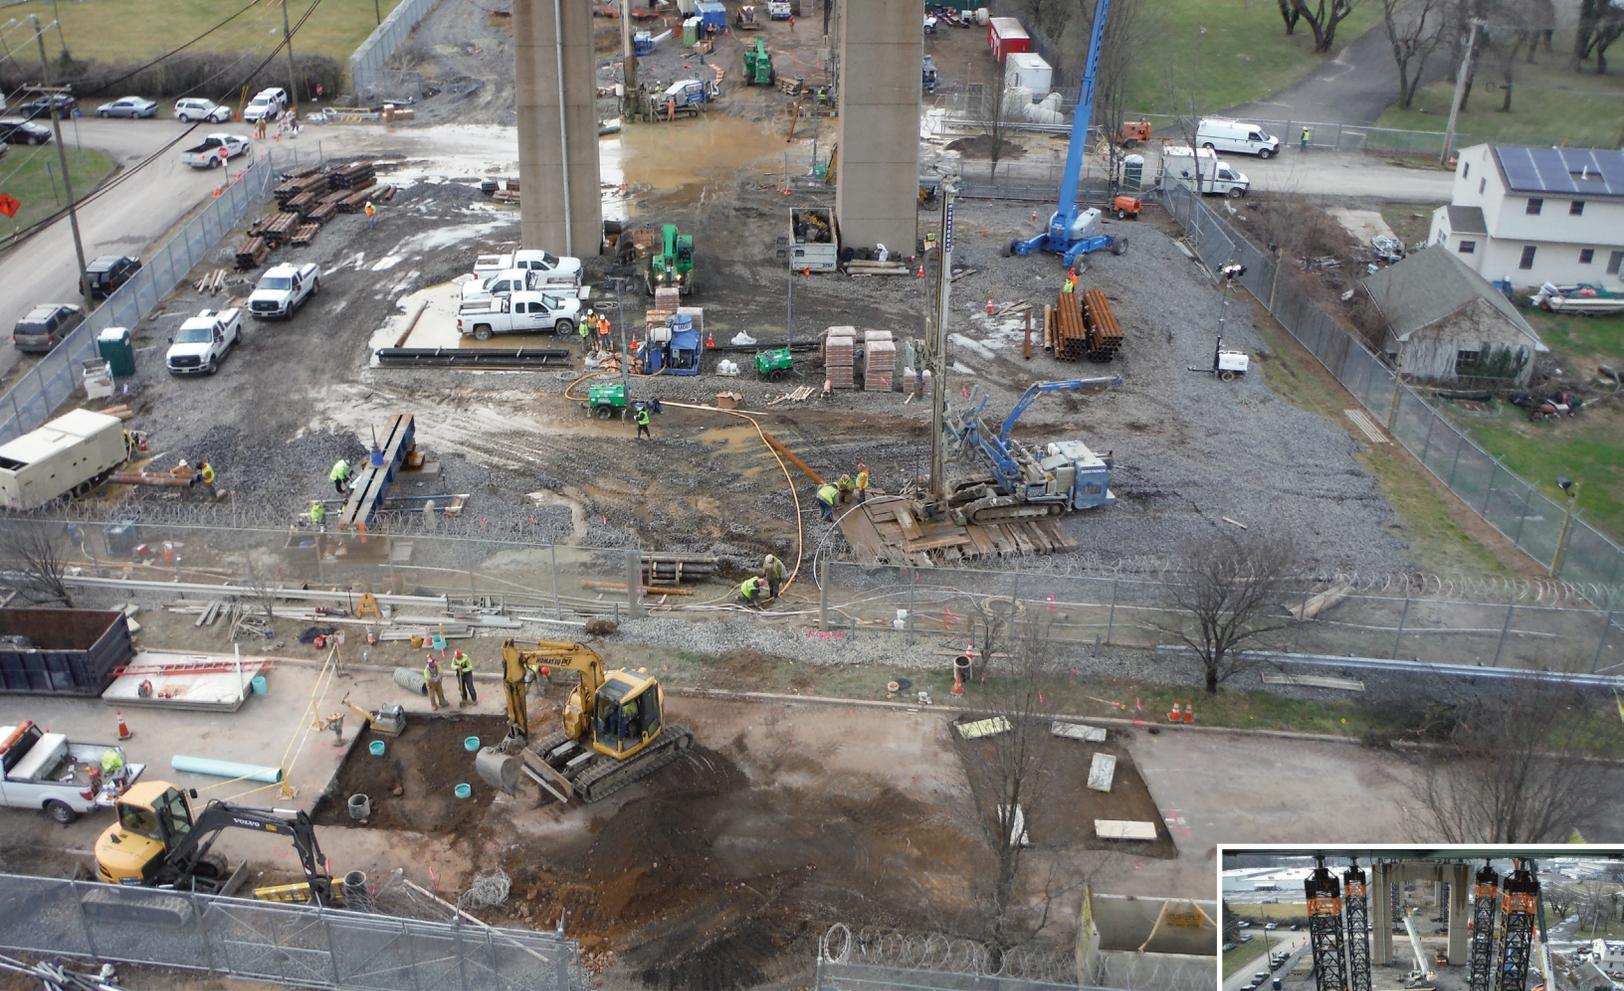
Photo 3: Micropile Installation

Once the temporary splice was installed, the next step was to install temporary support towers to continue to stabilize the structure and assist in the permanent repairs to the truss, which had sagged significantly in its new loading configuration. A total of eight towers were required to be constructed. It was decided to go with micropile foundations as it allowed for a much smaller footprint in the confined work area. Initial challenges associated with this tower installation included aerial and underground utility relocations and site preparation to accommodate the around the clock drilling operation. Overhead utilities presented direct conflict with the drilling operations. Efficient removal of the utility lines was coordinated directly with the utility owners by the construction management team. Similarly, close coordination with the utility companies helped to locate the underground gas, water and sewer lines. The benefit of utilizing micropile foundations was the flexibility to move piles to accommodate these underground utilities. (See Photo 3) To get a drilling contractor on site quickly,

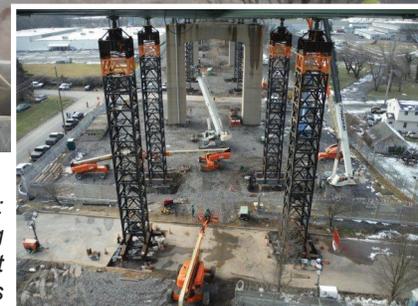
Photo 4: Jacking Support Towers

On February 24, the jacking operation went extremely well and was completed in one day. Though out the jacking

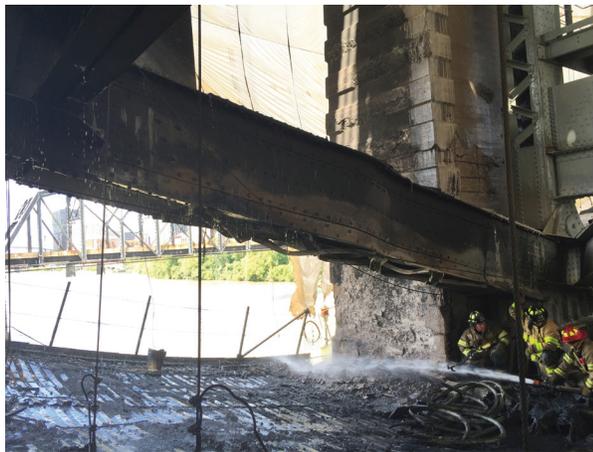
The Liberty Bridge rehabilitation project was made more challenging by an accidental construction fire that heated and buckled a main truss member, crippling the bridge. With dedicated teams working around the clock, the bridge was re-opened in just 24 days.

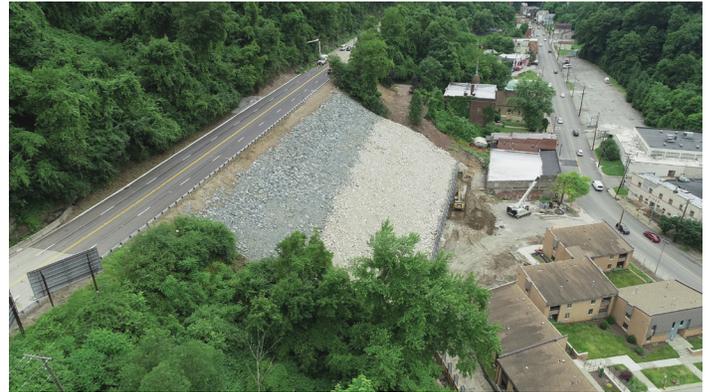
Completion of the Route 30 landslide rehabilitation was done in just 48 days, thanks to the cooperation of the project team's commitment

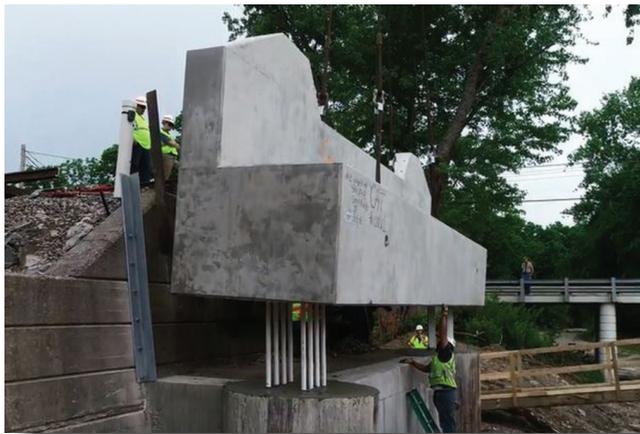
Precast Abutment Seat and Backwall

Given the age and condition of the structure, Norfolk Southern and Michael Baker International proposed to replace the structure with a new single-span bridge. With the critical nature of the rail operations on this line, it was decided that as much reconstruction as possible would be performed without disrupting train service. The solution proposed involved prefabricating a 52'-0" single-span through girder superstructure and precast concrete abutment seats, which could be rapidly placed during a 24-hour outage of the main line. The solution also called for the construction of two 5'-0" drilled shafts at each new abutment location, outside the footprint of the existing bridge. These four drilled shafts were installed while train service remained on the bridge. Connection details were provided at the top of the drilled shafts to allow for the installation of the precast abutment seats and backwalls.

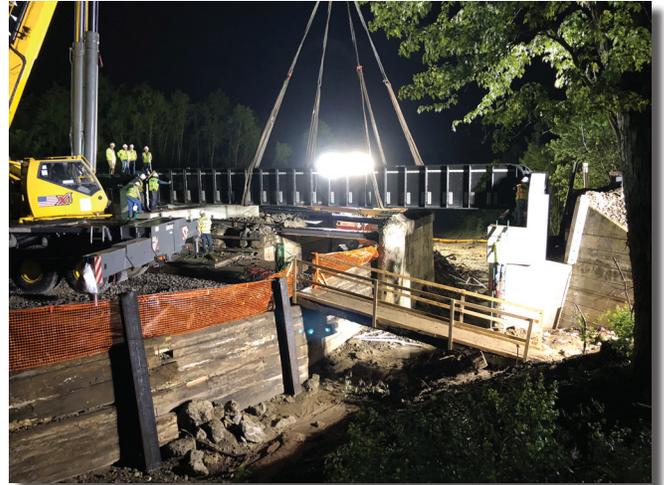
Placement of Prefabricated Superstructure

shafts. A new superstructure consisting of 5 ft-deep through girders, W21x101 floorbeams and a 3/4" steel plate deck, which was previously erected nearby on the site, lifted by crane, and placed on the new abutment seats, supported on rocker type bearings. Ballast was then placed on the deck, the track panel was re-connected, ballast regulators and tampers set the ties at the right elevation and track liner checked the rail alignment. This operation was all completed within the 24-hour closure, and full rail operations were reinstated the following day. Demolition of the old piers took place after full train service was restored on the new superstructure.

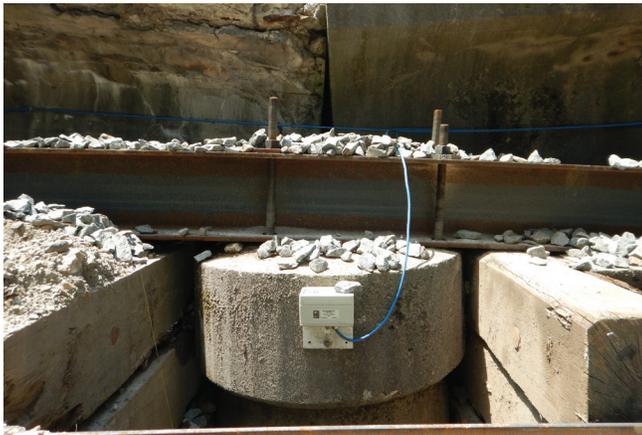
Monitoring and Instrumentation of East Pier

Geo Instruments, Inc. was subcontracted to install the monitoring system on the bridge, process sensor readings and maintain a project website that provided real-time data readings and graphs. The system was comprised of electrolevel tiltmeters, a hydrostatic level system and a data logger. The tiltmeters were connected at the mid-span on both sides of

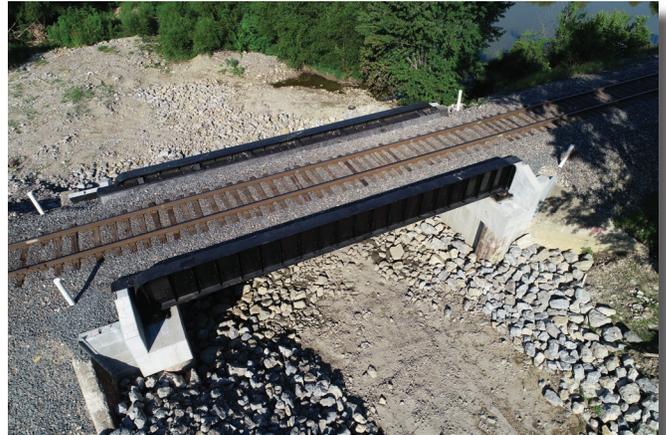
The new Norfolk Southern Bridge
