Project of the Year Submissions

Title: **Yards Creek Generating Station**

Yards Creek Generating Station

Pumped Storage Generating Station Reservoir Repair

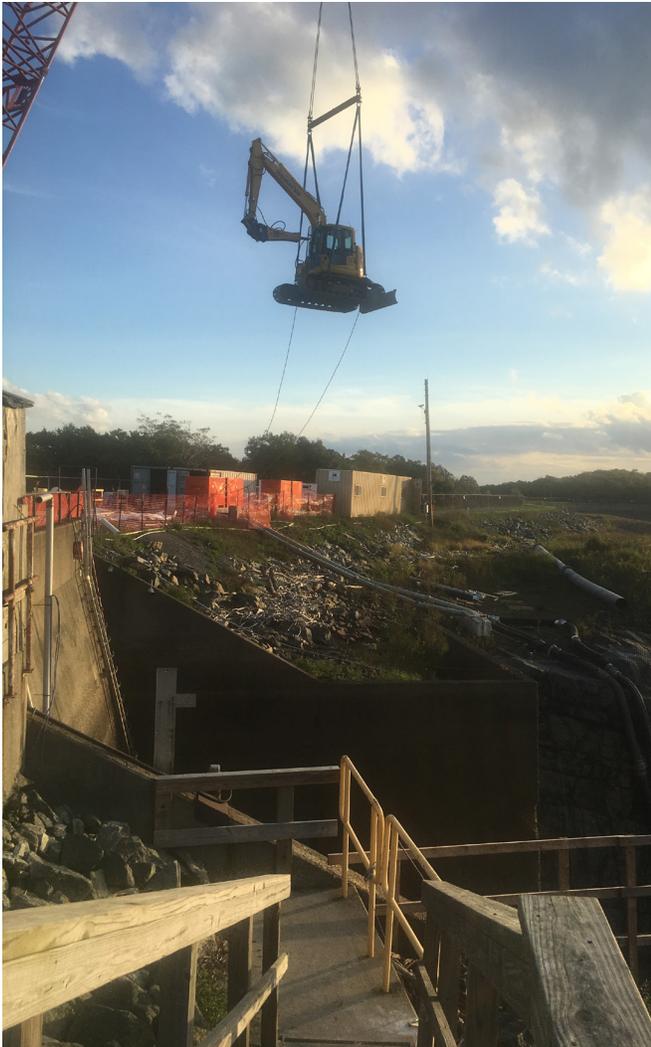
A crane was used to hoist an excavator into the intake to perform the demolition of the sidewalls.

- The first phase of work included the installation of temporary cofferdams, a temporary bypass pump, slope mesh to protect workers from rocks falling off the walls, rock anchors, and wheel gate embedded plates. The team demolished the center pier, intake sidewall and slab, and the concrete trash rack beams. The existing tunnel was reinforced with 1.5-inch rock anchors so that in the event of a pipe failure downstream, coupled with the rapid shutoff of the gates, the tunnel would not experience structural or catastrophic damage. All the demolition was located at the bottom of the intake, 120 feet straight down. This involved major use of crane operations. A crane was used to hoist an excavator into the intake to perform the demolition of the sidewalls. The center wall was removed using an engineered wire saw cut and lift plan. Over 30,000-pounds of concrete were removed from the pit during the select saw cutting process. Work also included the control building and duct bank to the gauge house.

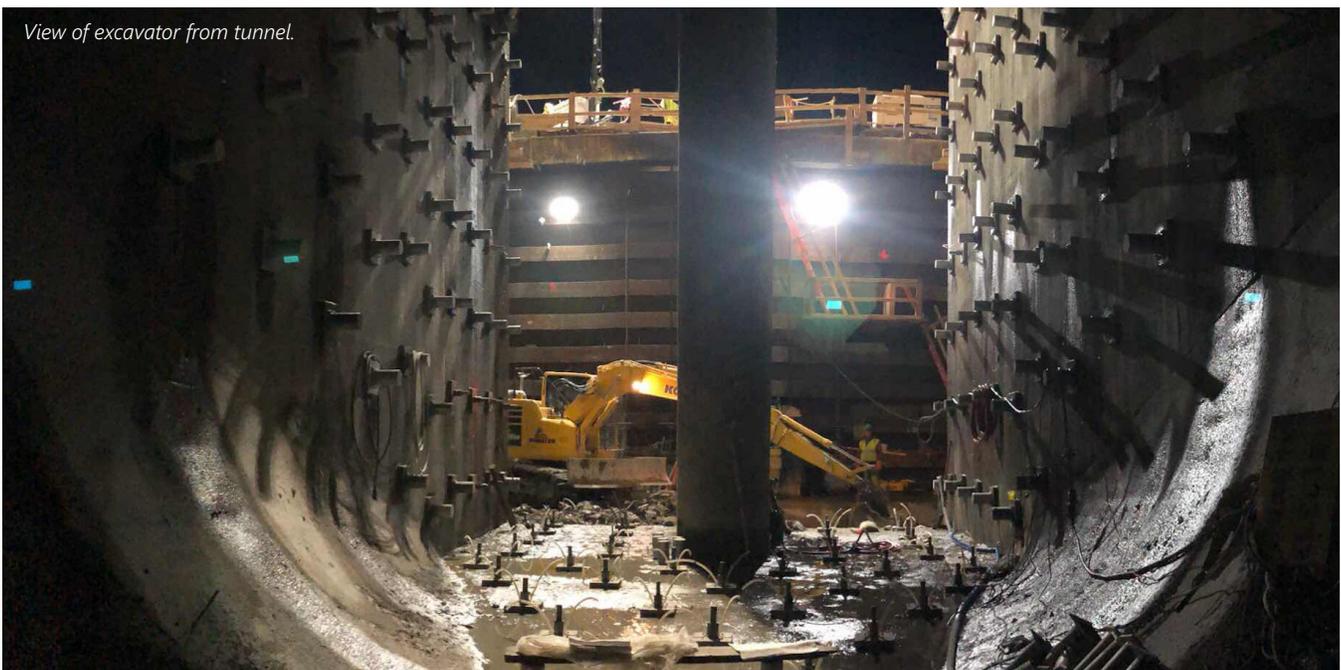
View of excavator from tunnel.

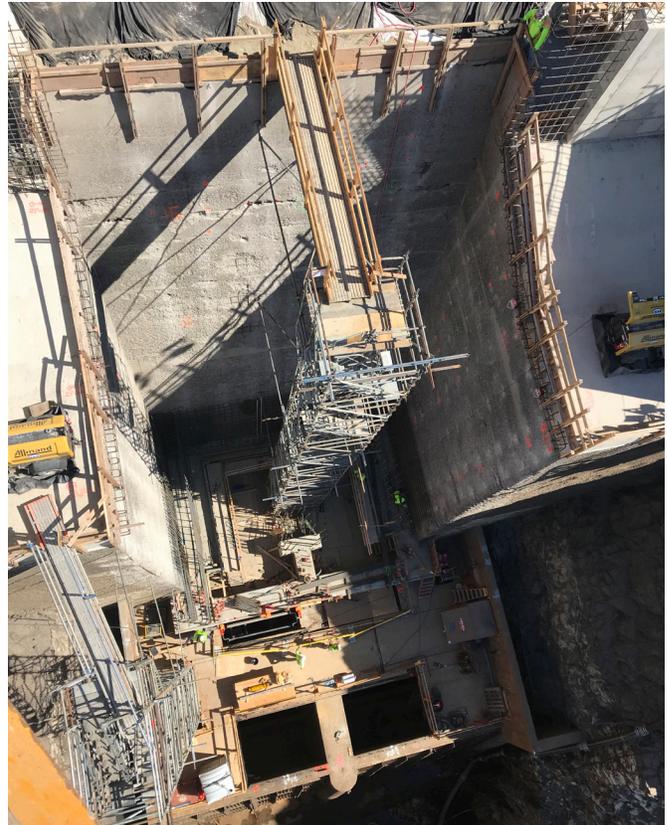
To enter the site, you walked out a 20-foot scaffold plank to reach the 120-foot-tall stair tower.

- The intake structure area of the project was an 81-foot by 76-foot footprint. The new intake structure was 107 feet tall with 95 feet of the new structure below grade. To enter the site, you walked out a 20-foot scaffold plank to reach the 120-foot-tall stair tower.

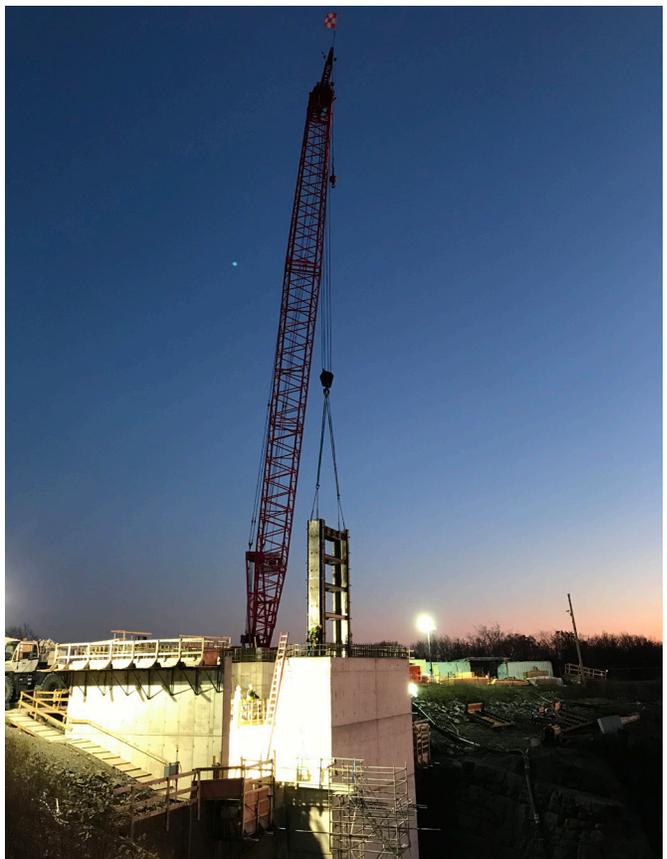
Crane operation was critical to the success of this project.

- Crane operation was critical to the success of this project. Crane operations were restricted at 20mph wind speeds and halted at 30mph wind speeds. The top of the intake dam was at the treeline elevation and positioned the boom of the crane well above the treeline in the area. There were periods where work would be halted for two to three days at a time. The ridgeline where the site is located is the first ridge of substantial elevation inland from the Atlantic Ocean. All weather systems moving west from the Atlantic Ocean including late season hurricane related weather and Nor-Easter Snow had a major impact.

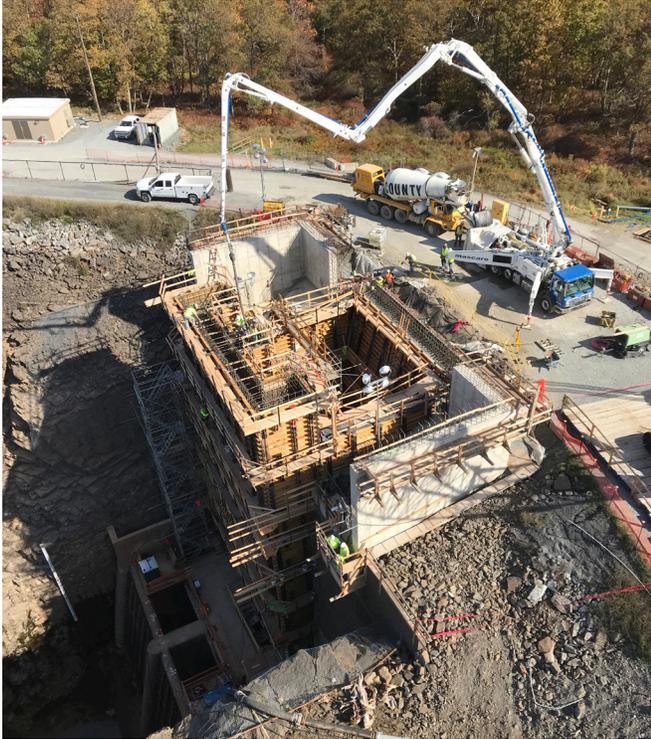
The project involved several mass concrete placements.

- The project involved several mass concrete placements. This involved finding not only a concrete plant that could support large placements, but also one that was nearby to ensure the material would arrive quickly. The challenge was to get the concrete there in a timely fashion and get it to the top of the mountain via the tedious escort process.

- Structural concrete – 2,530 cubic yards. 30 placements classified as mass concrete and required temperature monitoring. Over 110 IntelliRock sensors were installed and monitored throughout the project.

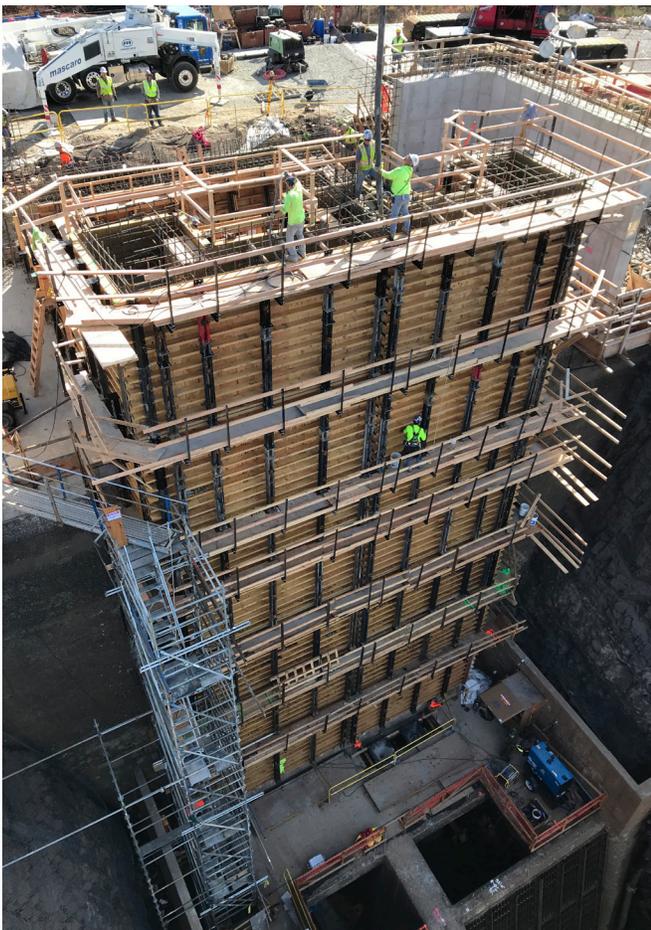
Detailed and custom-built formwork was supplied by Job Site Supply.

- Job Site Supply (formwork supplier) detailed and custom-built the formwork for the aggressive schedule. Knowing wind would restrict the use of the crane, the custom formwork allowed us to take advantage of the quick setting of the forms when the winds would die down, even for an hour, so we could then set the next lift of formwork – affording us with a productive day.

- Custom fabricated formwork was supplied to form the entire core of the structure at one time.
- Design and installation of formwork and associated temporary supports to construct 3,100 square feet of structural slab 105 feet above the intake floor.

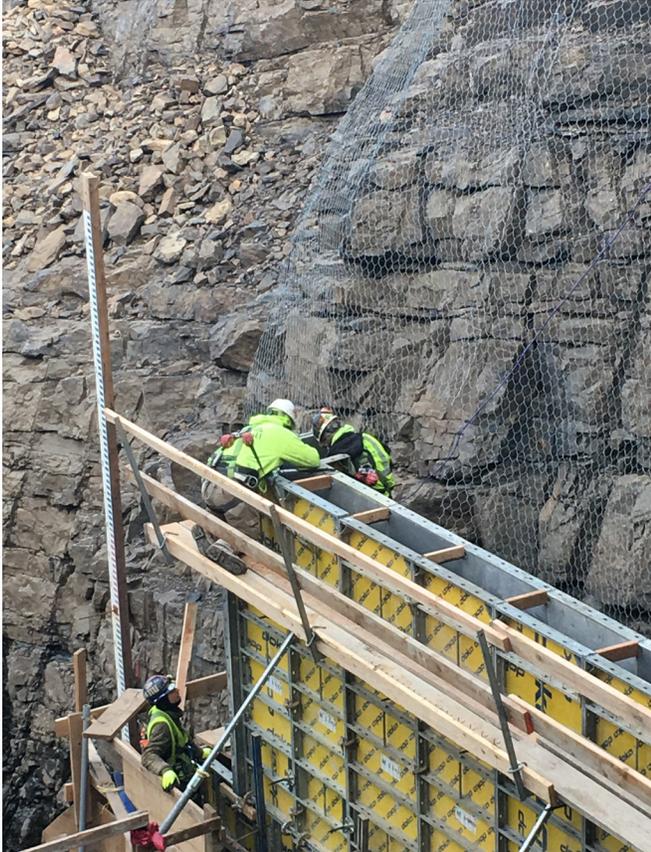
Slope mesh was installed to protect workers from falling rocks.

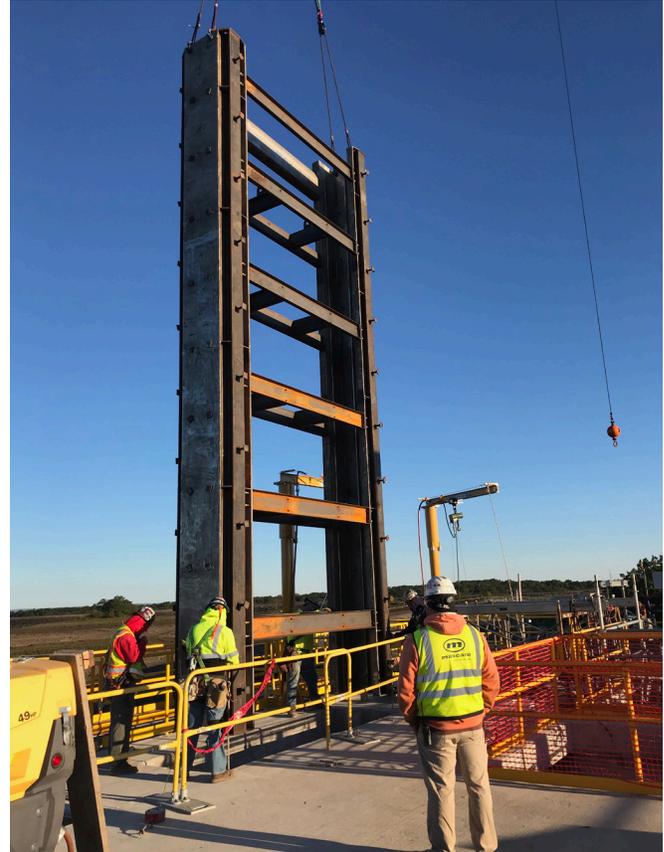
Installation of south wheel gate frame

- The third phase involved the installation of the wheel gate frames, wheel gate upper guides, wheel gates, and hoist as well as the supply, installation, and integration of a new supervisory control system to operate the gates.

- Concrete Reinforcing – 238 tons.
- Furnished and erected structural steel catwalks, platforms, stairs, and handrails.
- Installation of 200,000 pounds of embedded guide frames at a ± 0.05 in tolerance.

- Installation of two 66,000-pound wheel gates that are lifted by two 37,500 lb hoist assemblies, 12 feet wide by 30 feet tall.
- Total weight of critical lift equipment installed 474,000 pounds.

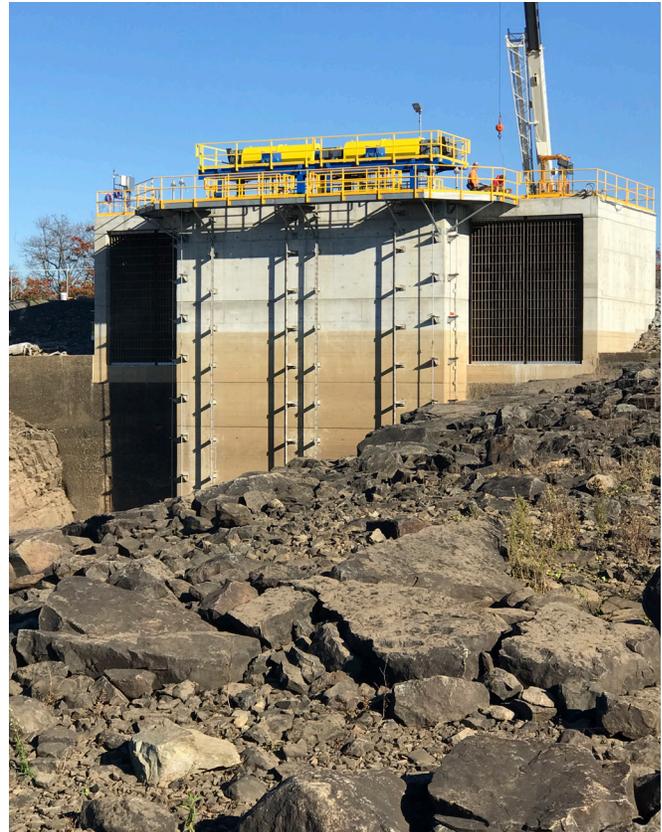
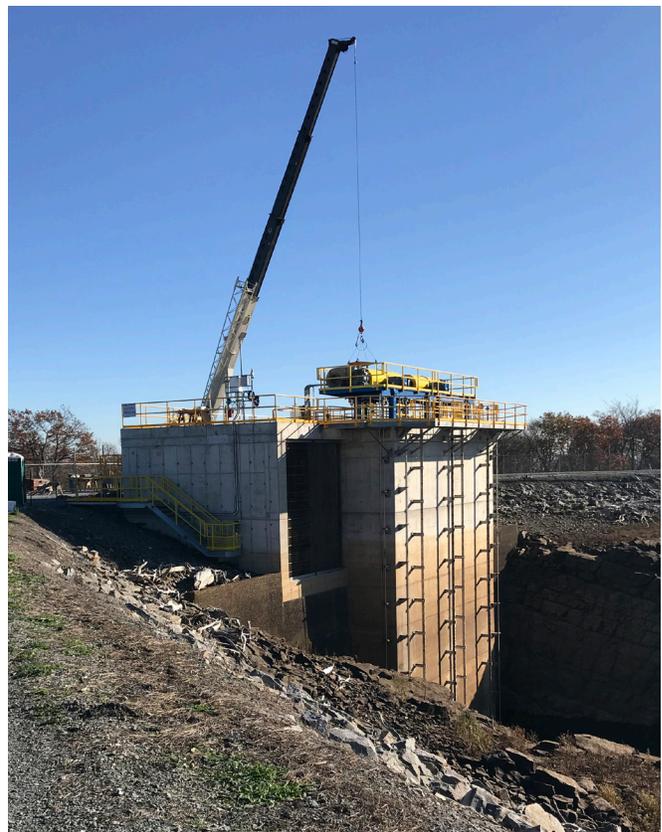
Completed photos of the Yards Creek Generating Station Pumped Storage Generating Station Reservoir Repair (above and below)
