**ESWP** Liberty Bridge ESWP Project of the Year Award Nomination

January 2019

### Liberty Bridge: from Life Support to Supporting Life

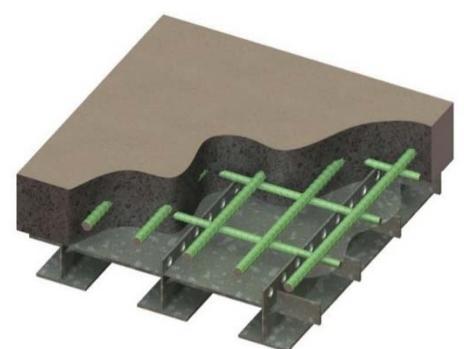
custom rapid-set This was the first Exodermic deck in Pennsylvania concrete mix was created for this project, which

By utilizing the first Exodermic deck in Pennsylvania, impacts to 55,000 vehicles a day were reduced while a deck the size of three football fields was replaced. Sections of this deck were

prefabricated in panels that could be installed over weekend closures and connected together with high early strength concrete. A custom rapid-set

allowed traffic to use new deck sections just a few hours after the concrete was placed. The new deck combines the strength of steel Tbeams with reinforced concrete on top; making it strong, light and easy to overlay in the future.

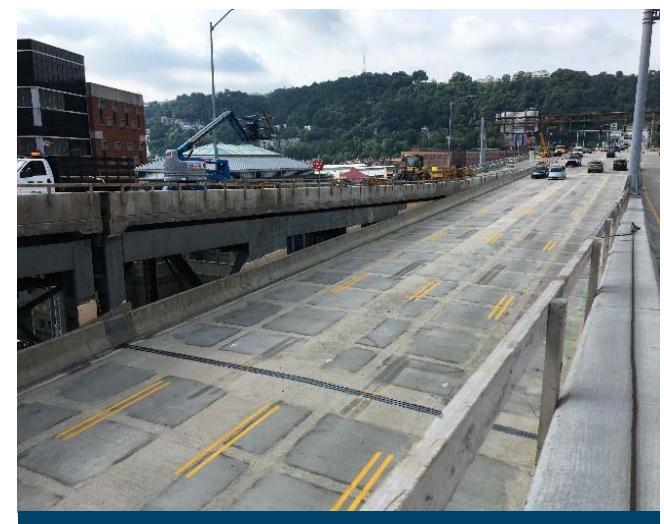
North end of bridge (prior to overlay) showing checkerboard of rapid set concrete and new deck panels, installed over weekends.

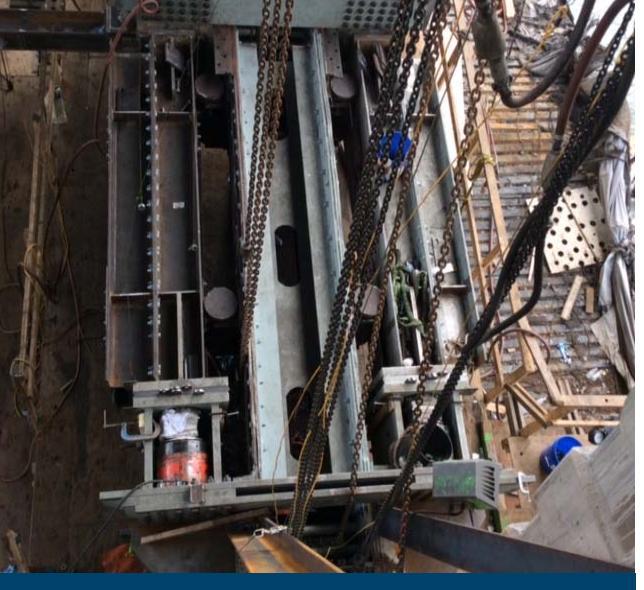
Jacking frame and repaired truss member

Without a historical precedent to go by, engineers also developed a jacking frame concept that same day to fix the buckled member. This frame would attach to the member to straighten the buckled steel. The final jacking frame included 11 jacks. Four 565ton jacks were aligned with the frame, capable of applying more than 4 million pounds to stretch the damaged member. Six 100-ton jacks were located on the sides of the frame, and would be used to straighten out severe buckles of the main structural plates, and the last 100-ton jack was located on a new bracing system added at the upper joint, and would fix the rotation evident at that joint. The whole system was designed to work together to twist, straighten, and stretch the damaged member back to its intended geometry.

To maintain safe operation of this complex machine, a 77-step jacking plan was developed. This plan included hold points when key steps were reached, so displacement and force data being collected through strain gages and instrumentation surrounding the frame could be processed. This data was used in real time to monitor the stiffness of the structure under load, and verify that structural response aligned with expectations from extensive 3D modeling. Through use of this sophisticated frame, the contractor safely rotated the upper joint and straightened the twisted member twenty-four days after the fire. On a momentous day for Pittsburgh commuters, traffic was restored on the bridge.
